Manhole Inspection Summary

Manhole # S31GG_034MH

Insp Date: 1/30/07 10:03 AM

Location Address: **1204 HOWARD ST**

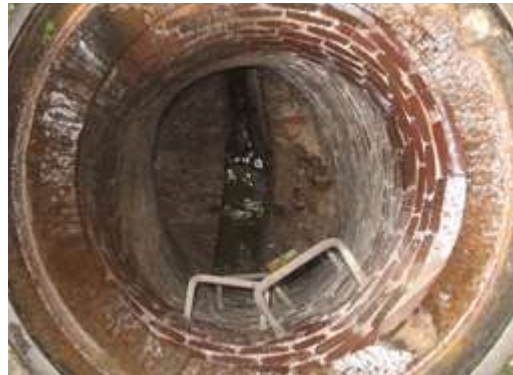
Top View

Bench and Channel debris.

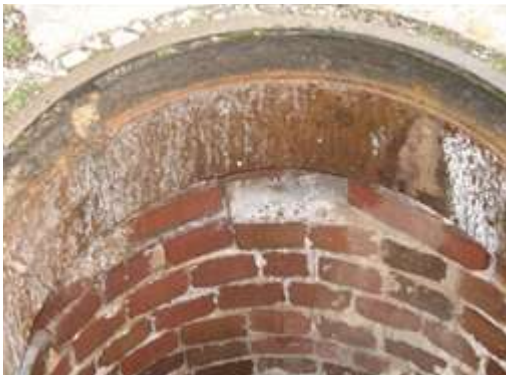
Defect

Adjustment deterioration and infiltration.

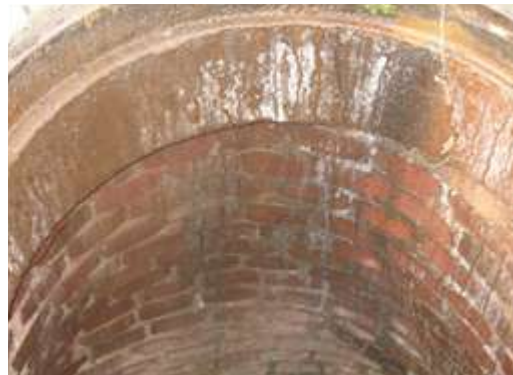
Defect

Frame leaks. Adjustment deterioration and infiltration. Barrel infiltration.

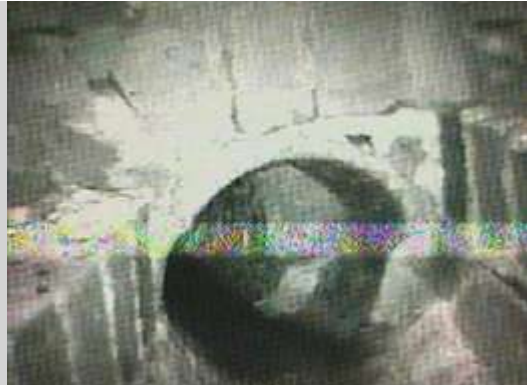
8 in. Circular Gravity Sewer Pipe Out @ 12 O'Clock

Infiltration: **Evidence** Pipe Seal Cond: **Cracked**

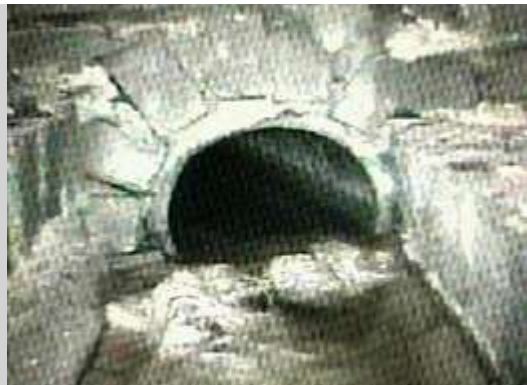
8 in. Circular Gravity Sewer Pipe In @ 7 O'Clock

Deposits: ☐ None ☒ **Mud** ☐ Sludge ☒ **Debris** ☒ **Grease**

Silt Depth: **1** (in.) Deposits Extent: **Light**

Infiltration: **Evidence** Pipe Seal Cond: **Cracked**
